Project: Spot repairs of Concrete Pipe

Location: Santander, Spain

Spot retrofit repairs in 1200mm Concrete Pipe in Santander, Spain.

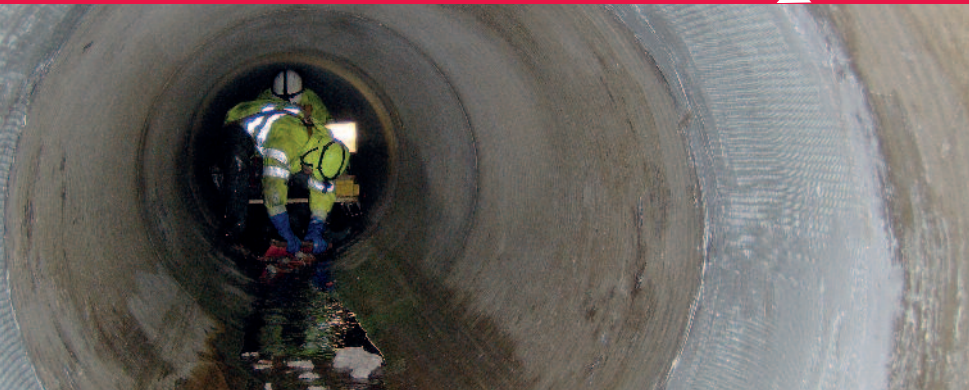
This infrastructure, buried at more than 12 meters, suffered significant breaks in seven points after being punched by tensioning cables during construction of a neighbouring building.

After cutting these cables running through the pipe, a provisional mortar was applied to tap the holes. In order to recover full integrity as original, the sealing and reinforcing of the pipe in the damaged areas was performed by applying specialized primer as first, followed by two layers of fiberglass Tyfo SEH saturated with high performance epoxy resin system. These latter were applied in hoop direction around the full perimeter of the pipe.
